# Circulation Facilities and their Impact on Comfortable Use in Government Girls Primary School, University Campus, Karachi, Pakistan

This research study aims to determine the relationship between circulation facilities and their impact on users' comfort. The study was carried out at a Government Girls' Primary School, University Campus located in Gulshan-e-Iqbal Town (Female), District East, Karachi (Semis Code No. 408080064), Pakistan. Data were gathered and analyzed using both quantitative and qualitative methods. In the quantitative method, questionnaires were used, and in the qualitative method, observations (site visits, architectural drawings, and photographs) were used for staff members: teaching staff (academic staff) and support staff (general staff). According to the findings, circulation facilities were statistically significantly related to the performance and turnover rates of staff members: teaching staff (academic staff) and support staff (general staff).

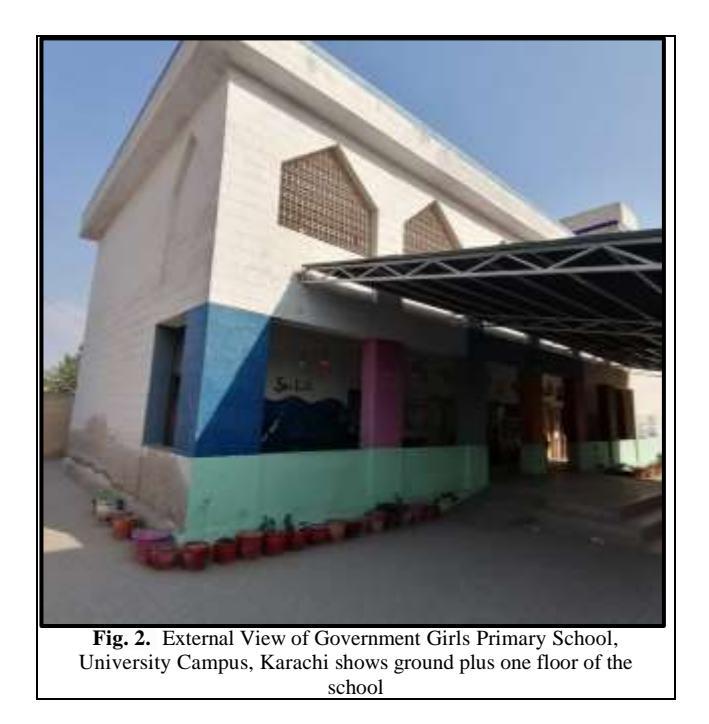
When one arrived at the school, it was made of concrete and had a solid mass. It consists of a ground-plus-onefloor structure. The school had adequate space for outdoor activity areas, adequate natural lighting, colorful soft boards in the corridors, and good ventilation.

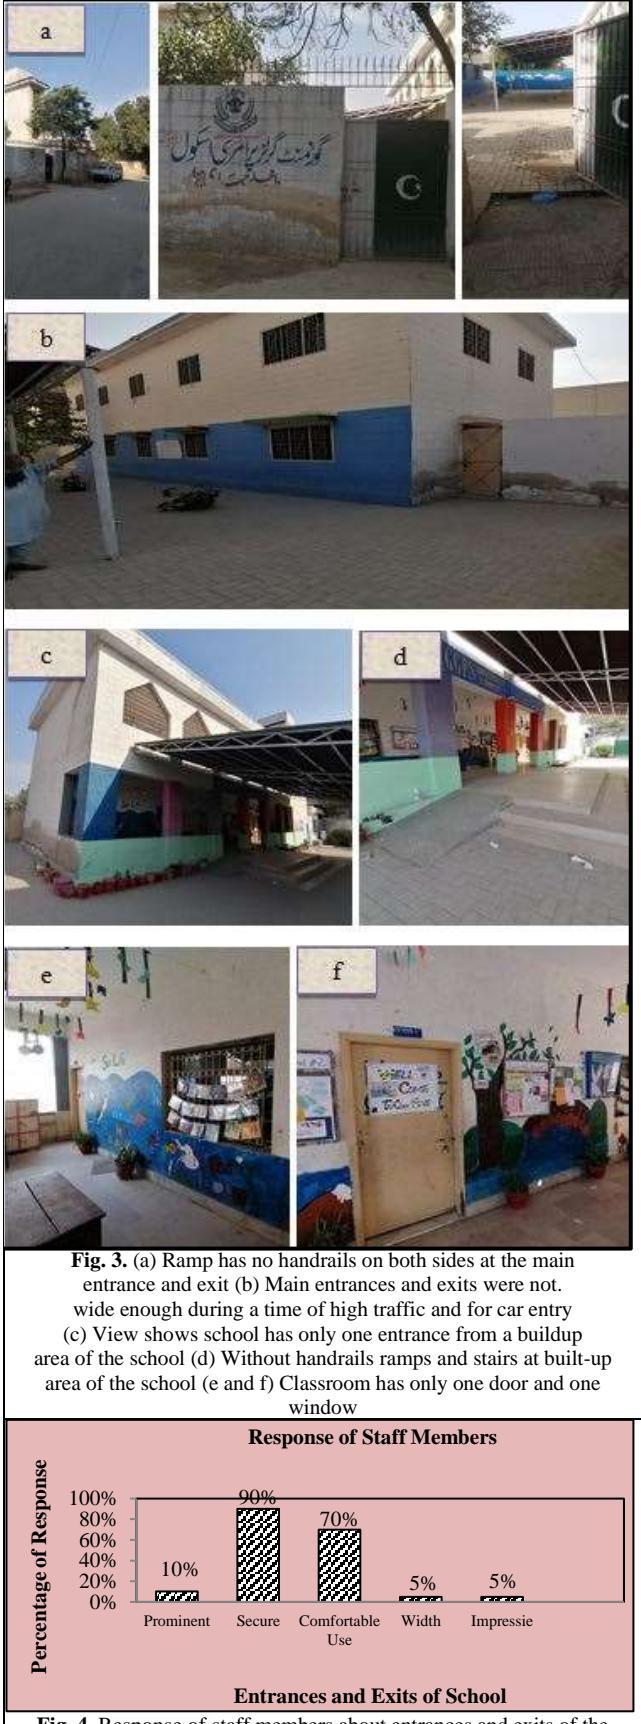
When asked about the school's entrances and exits, 10% of respondents stated that the entrances and exits were prominent, so they could not easily reach them; 5% said they were impressive; 5% said the main entrances and exits of this school were wide enough for cars to enter, while 90% said the entrances and exits were secure, and 70% said they were comfortable to use, as shown in Figs. 3 and 4.

Yet, it was observed that the entrances and exits were not prominent, impressive, or wide enough that even cars could not enter from the two main entrances while they were secure and comfortable. This is important to note here because, due to the excessive movement of users and cars, they could not enter from the two main entrances in the school selected, making it unavoidable to provide wide entrances and exits.

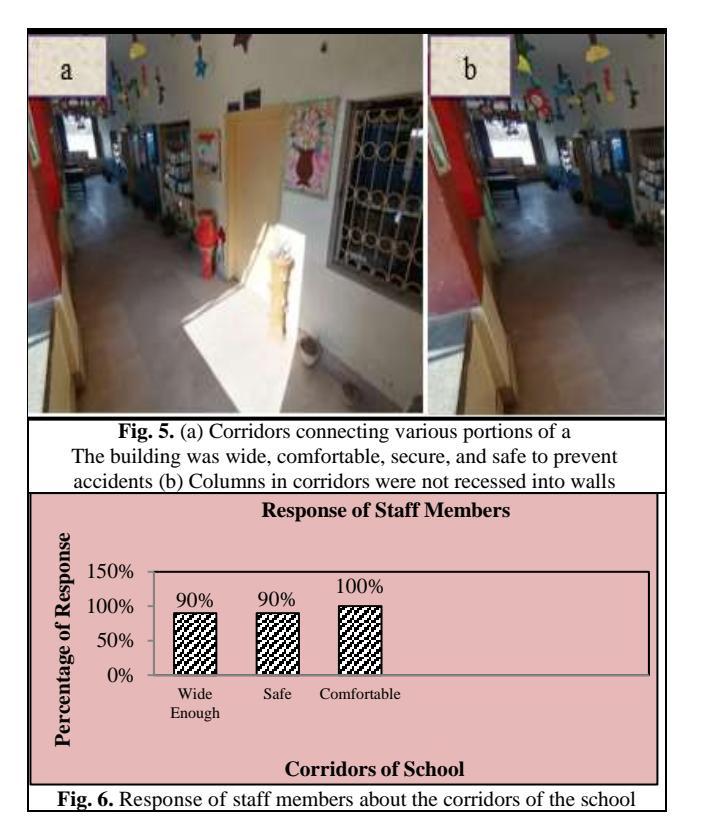
Of the defendants, 90% showed that the corridors were wide sufficient and could be used conveniently; 90% of defendants showed that the corridors were safe to prevent accidents; and 100% of defendants showed that the use of the corridors was comfortable, as shown in Figs. 5 and 6.

However, columns in corridors were not sunken into the walls. But corridors were comfortable, secure, safe, and wide enough to accommodate two wheelchairs passing each other without feeling crowded and for other mobility aids as well as two-way traffic. Classrooms were surrounded by corridors; as a result, they also served as the entrance to the classrooms. This is important to note here columns in this school's corridors should be recessed into the walls.

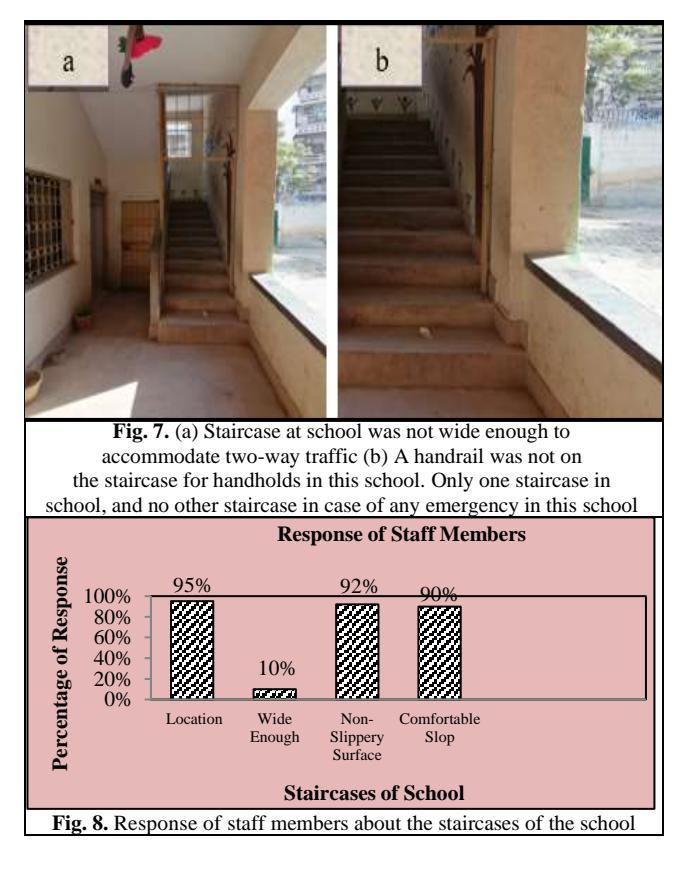
The graphs in Figs. 7 and 8 demonstrate that just 10% of respondents were content with the staircase's width, while 95% of respondents were content with the staircase's placement, 92.5% were content with the non-slip surface, and 90% were content with the staircase's comfortable slope.

Researchers observed that the staircase was not wide enough. While the location of the staircase was perfect, the staircase was easy to use with a non-slippery surface. And adequate space was allotted to achieve a comfortable slope. This is important to note here the staircase should be wide enough to accommodate twoway traffic. A handrail on the staircase should be available, and it should be sturdy in this school for handholds. And is also cited in Section II: Literature Review, as listed in standards [20], [22], and [23], and referred to by scholars [27] and [28].

Furthermore, for vertical circulation, there was no other staircase in the school. Other staircases should be available in this school in case of an emergency. The location of the staircase was perfect. Adequate space was allotted to achieve a comfortable slope in the design of the staircase. The staircase was easy to use with a non-slippery surface, easy to climb and descend, and accessible to all with adequate lighting and ventilation. There shouldn't be more than 12 steps in a flight of stairs that connects landings on different floors. The school building's staircase was designed accordingly. The staircase at school was not wide enough. It was only 3

feet and 6 inches wide. It should be wide enough to accommodate two-way traffic. A handrail was not on the staircase. A handrail on the staircase should be available, and it should be sturdy in this school for handholds. In essence, handrails contribute to stability by preventing people from sliding or losing their footing and collapsing. Similarly, there was no ramp in the school. Ramps should be available in this school for emergencies, wheelchairs for physically challenged users, for the elderly, and baby strollers. Ramps are also the ideal circulation features to apply in the design and should be incorporated into the functional space of the school in an inventive way. A ramp consumes a lot of space in an attempt to achieve a comfortable slope, but a ramp is a better alternative for vertical circulation. A ramp's width should be sufficient for wheelchairs and baby strollers to move in both directions at the same time. A handrail should be on the ramp for handholds. In essence, handrails contribute to stability by preventing people from sliding or losing their footing and collapsing. Furthermore, there was no lift in the school. Lifts should be available in this school for physically challenged users, the elderly, and those pushing baby strollers. If there are stairs nearby, the lifts should always be situated next to them to provide an alternative route. Lifts in a school building should be easily visible from the entrances. The lifts should be large enough and easily accessible to accommodate a small group of people, as well as have wide doors that can accommodate wheelchairs. A handrail in the lift should be available for handholds.

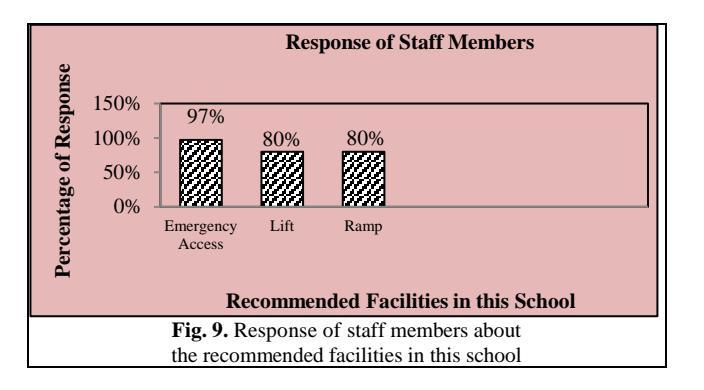
The above Fig. 9 graphical representation shows that 97% of respondents suggested that there should be emergency access (from built-up areas of the school, from classrooms, and the upper floor in the form of a staircase and ramp), 80% of respondents suggested that there should be a lift in the school, and 80% of respondents suggested that there should be a ramp in this school.

It was observed that emergency access was not present in the school in case of fire or any emergency. This is cited in section II: Literature Review, as listed in standards [20, 21, 22, 23] and referred to by scholars [28].

The same is the case with the ramp, which was also not there. Ramps should be available in this school for emergencies, wheelchairs for physically challenged users, for the elderly, and baby strollers. This is cited in section II: Literature Review, as listed in standards [20, 22, 23] and referred to by scholars [24, 27, 29].

Some of the other facilities that are not present in the school are listed as "lifts." Lifts should be available in this school for physically challenged users, the elderly, and those pushing baby strollers. This is cited in section II: Literature Review, as listed in standards [20, 22, 23] and referred to by scholars [29].
